APPENDIX C. VISUAL INSPECTION PHOTOGRAPHS

C1. Photograph Station Information

C2. Year 7 (2019) Photographs

C3. Comparison Photographs

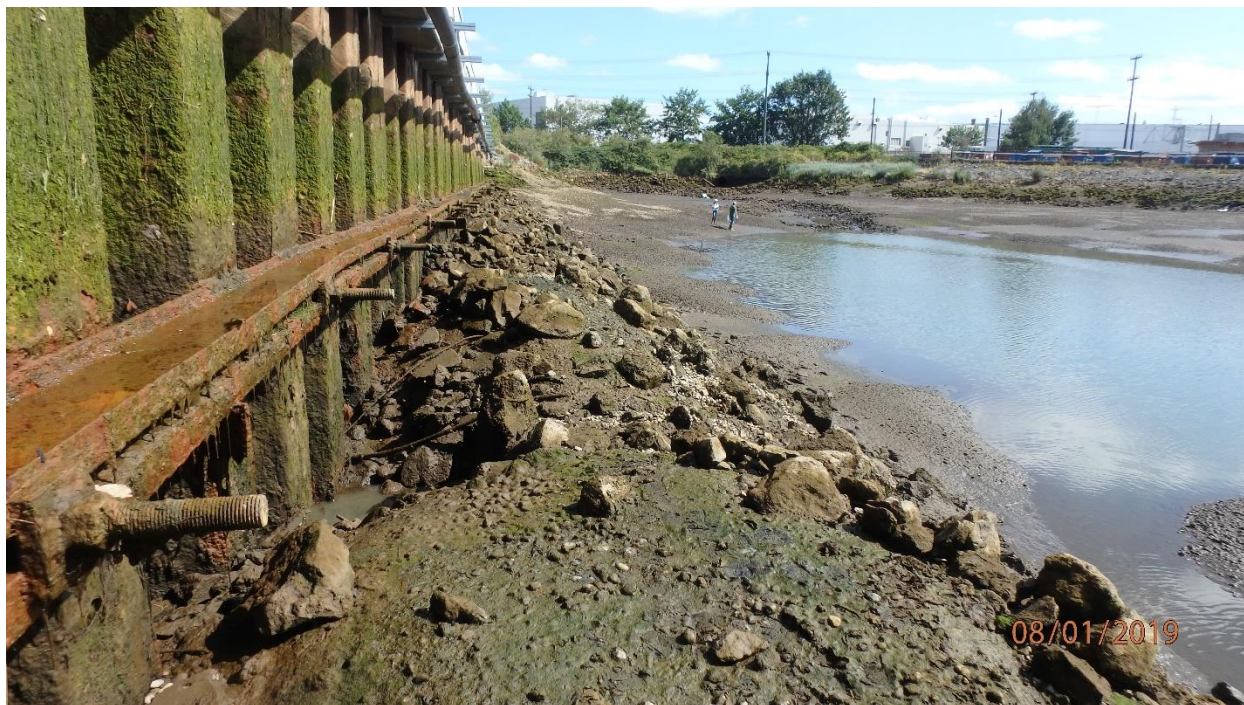
Photo A1. Vantage from photo station A looking northeast toward the east central sediment cap; Azimuth 55° Magnetic (M); 10:44 PDT, water level approximately -2.04 ft MLLW

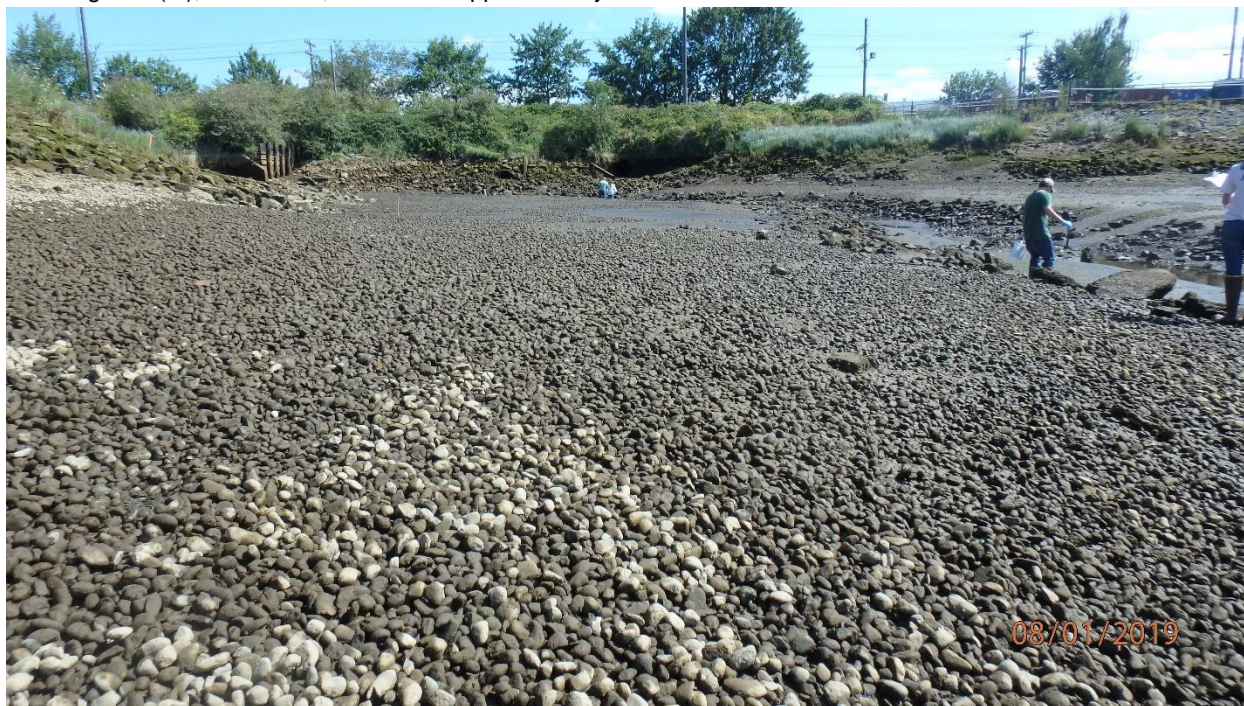
Photo B1. Vantage from photo station B looking toward the north sediment cap; Azimuth 48° M; 10:50 PDT; water level approximately -2.33 ft MLLW

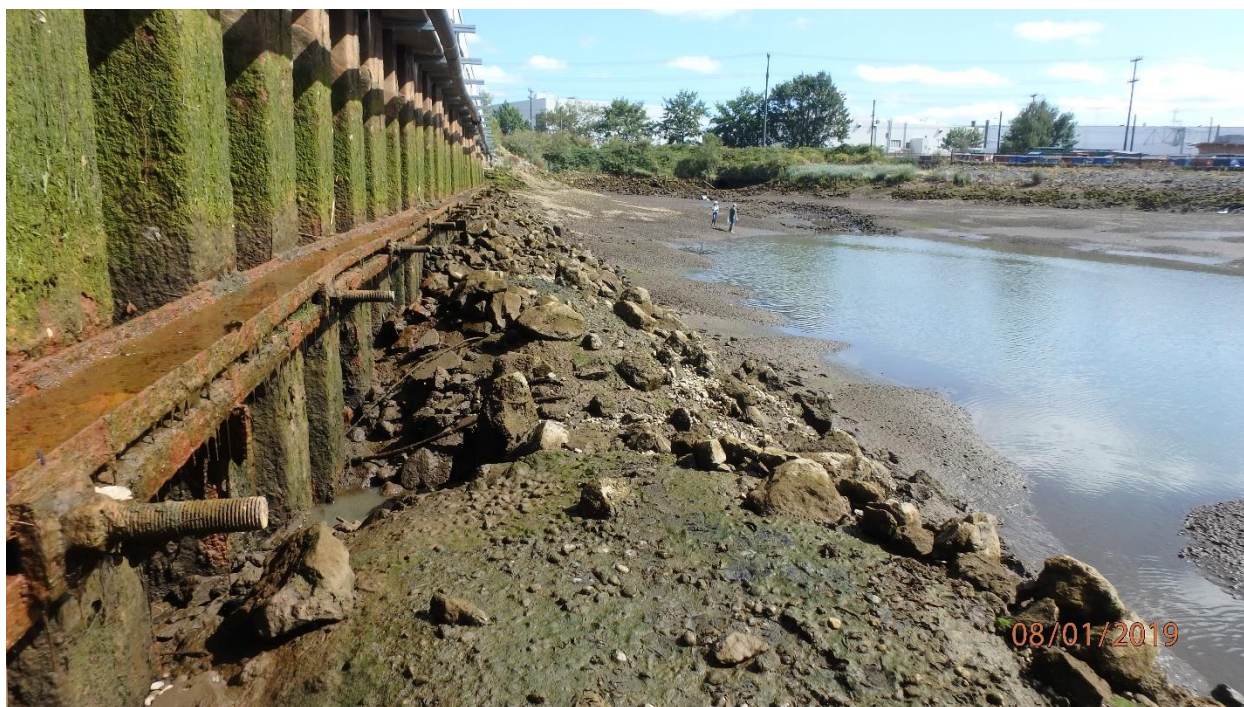
Photo A1. Vantage from photo station A looking northeast toward the east central sediment cap; Azimuth 55° Magnetic (M); 10:44 PDT, water level approximately -2.04 ft MLLW

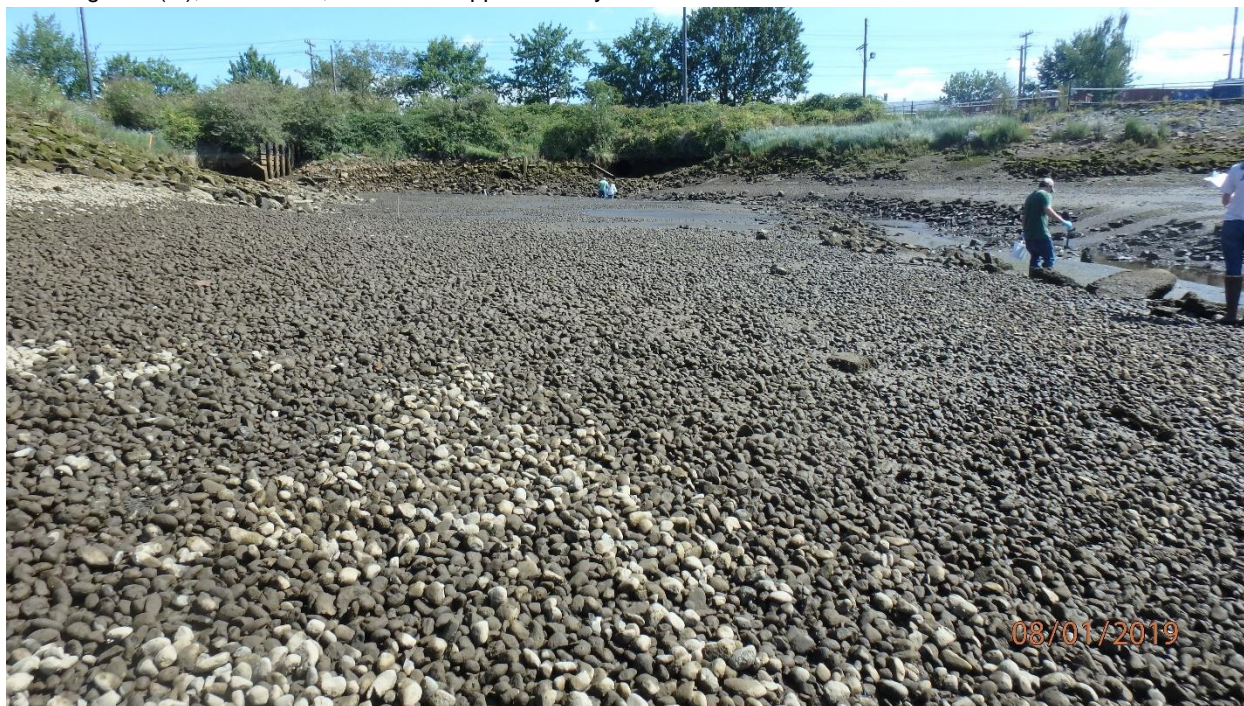
Photo B1. Vantage from photo station B looking north toward the sediment cap; Azimuth 48° M; 10:50 PDT; water level approximately -2.33 ft MLLW

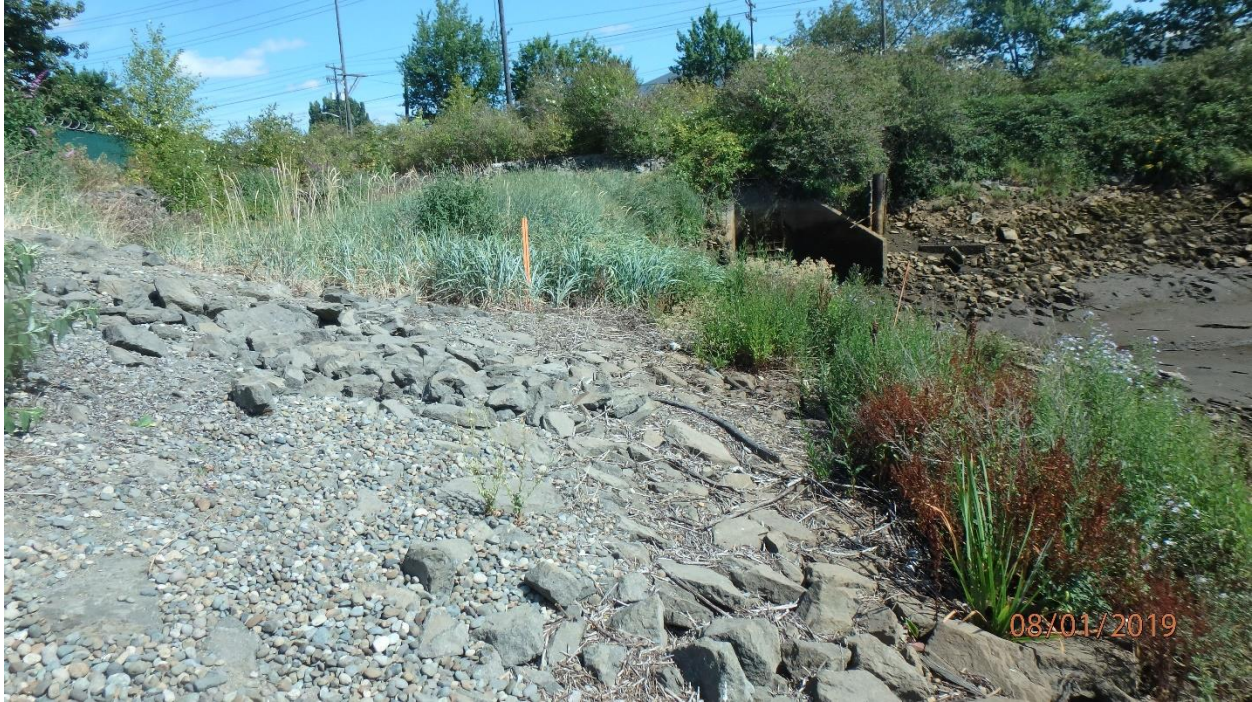
Photo D1. Vantage from photo station D looking northeast toward the northwest beach and anchored logs; Azimuth 8° M; 11:03 PDT, water level approximately -2.48 ft MLLW

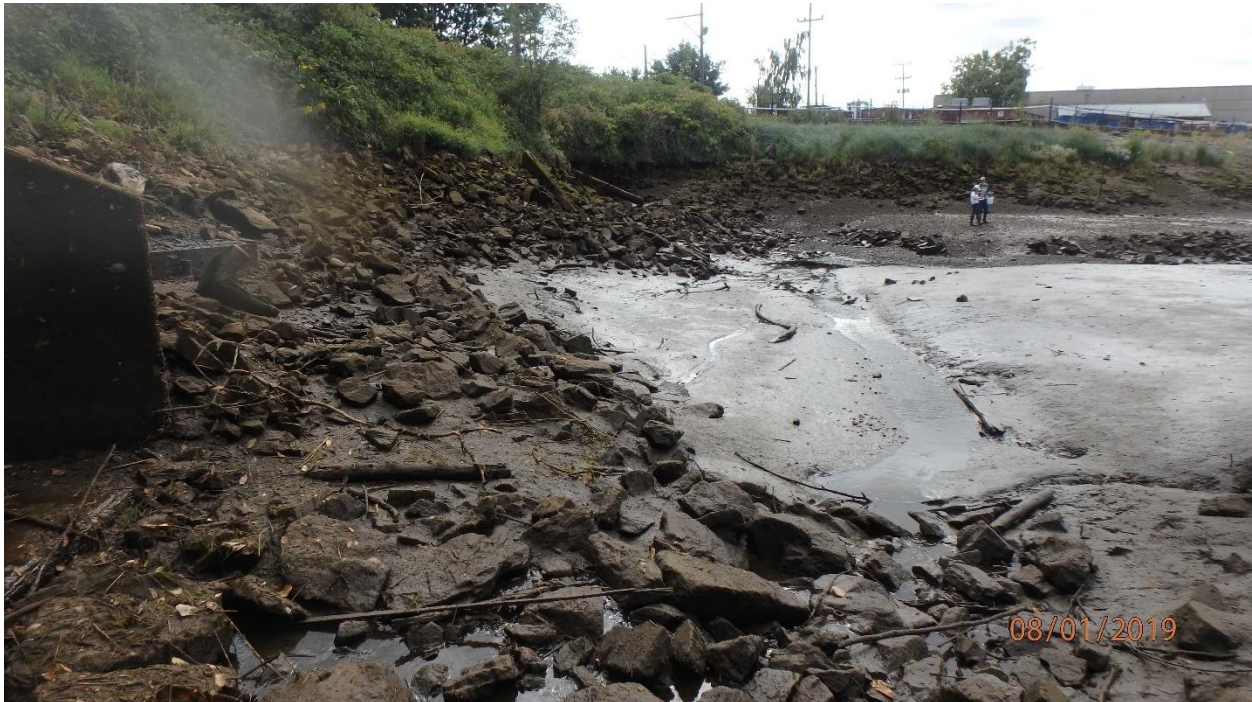
Photo E1. Vantage from photo station E looking southeast toward the north slope cap and outfalls; Azimuth 102° M; 10:04 PDT, water level approximately -0.75 ft MLLW

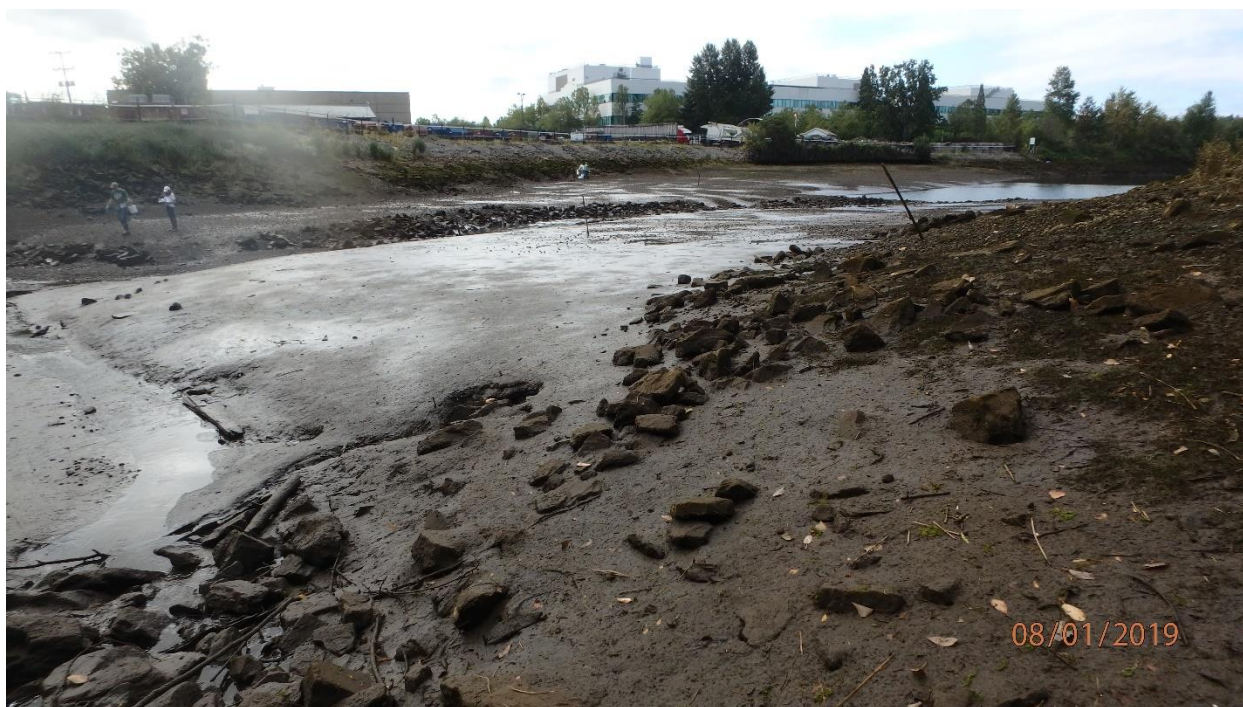
Photo E2. Vantage from photo station E looking southeast toward the northeast slope cap and north slough; Azimuth 144° M; 10:05 PDT, water level approximately -0.75 ft MLLW

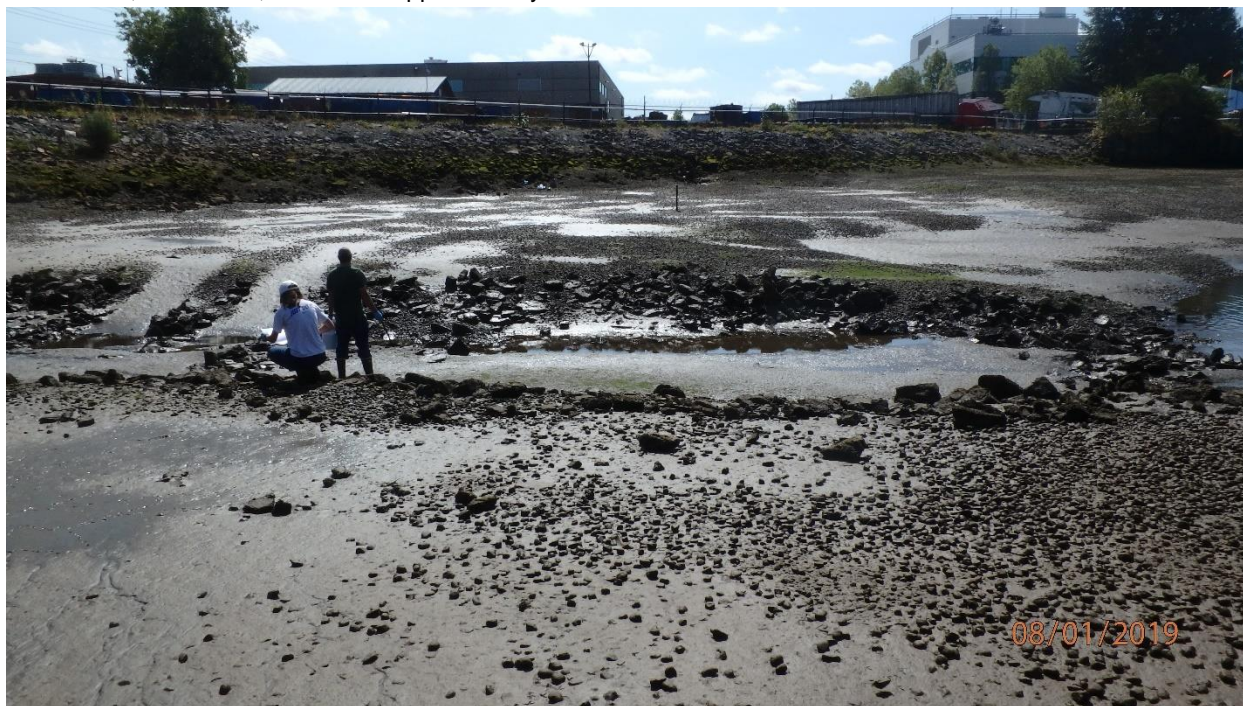
Photo F1. Vantage from photo station F looking southeast toward the east slope cap, east sediment cap, and central slough; Azimuth 133° M; 10:54 PDT, water level approximately -2.33 ft MLLW

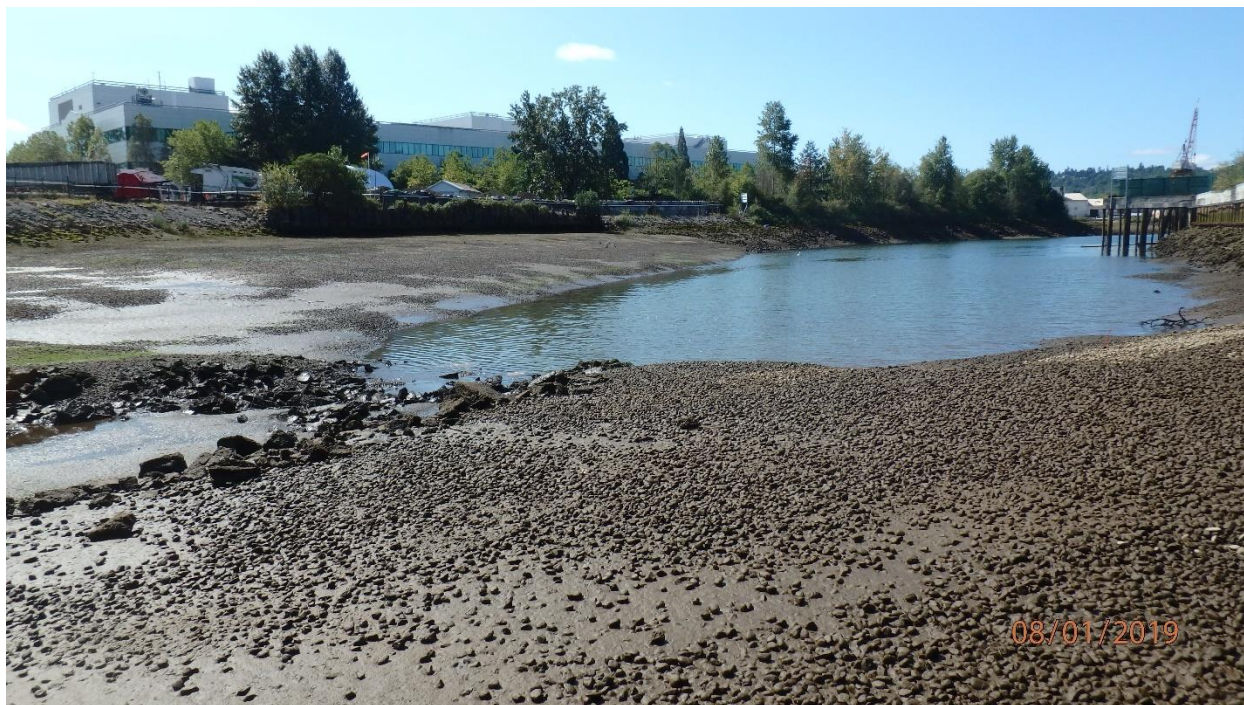
Photo F2. Vantage from photo station F looking southeast toward the southeast slope cap and southeast sediment cap; Azimuth 165° M; 10:56 PDT, water level approximately -2.33 ft MLLW

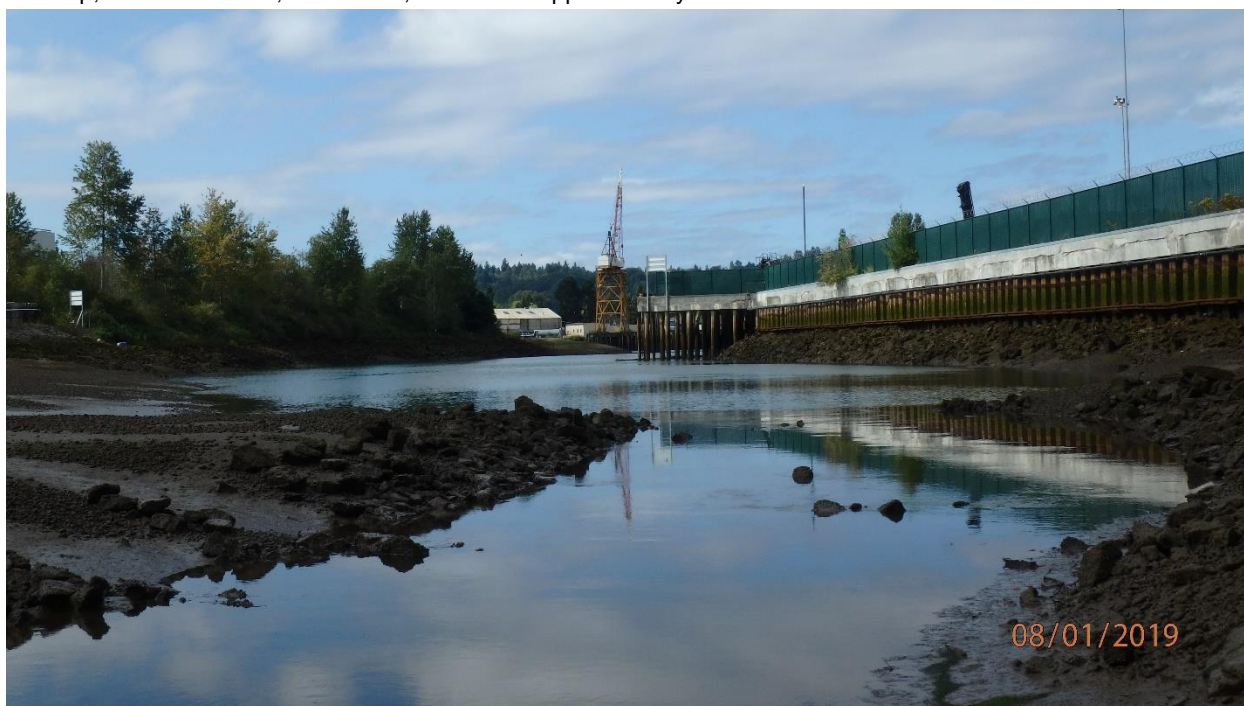
Photo G1. Vantage from photo station G looking southwest toward the south slough; Azimuth 200° M; 10:15 PDT, water level approximately -1.24 ft MLLW

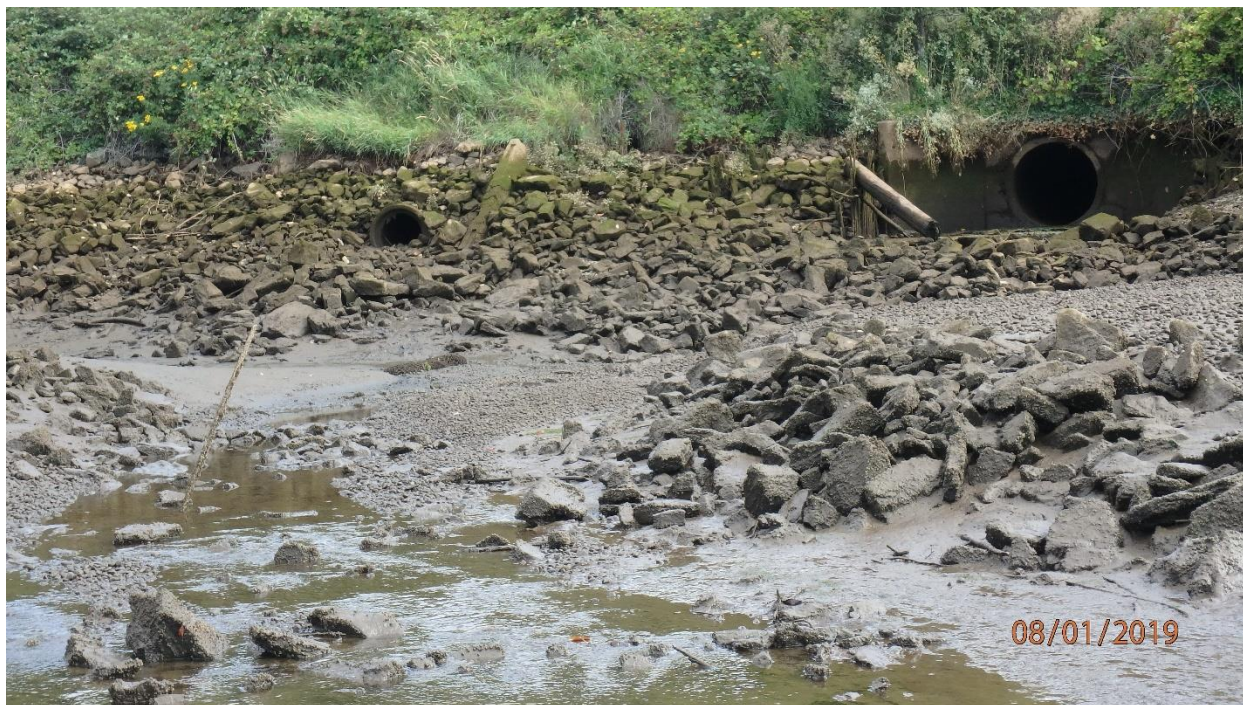
Photo G2. Vantage from photo station G looking northeast toward the north slough, north sediment cap, and north slope cap; Azimuth 27° M; 10:16 PDT, water level approximately -1.24 ft MLLW

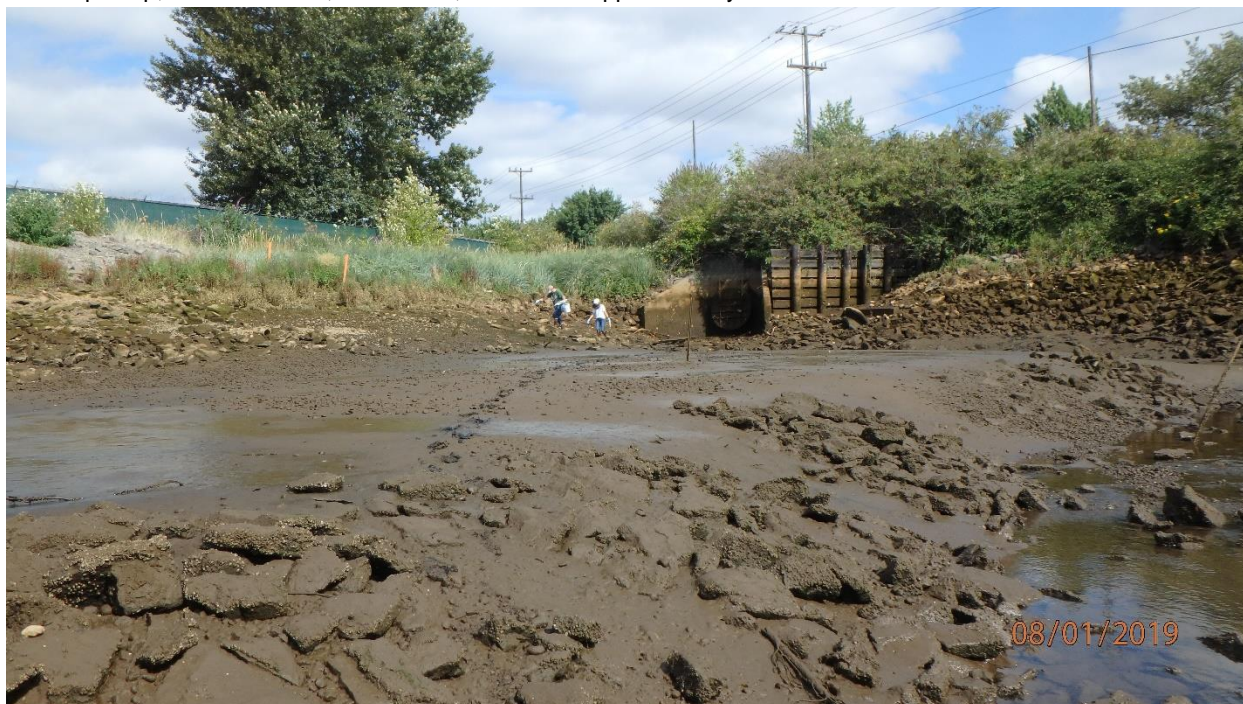
Photo G3.1. Vantage from photo station G looking north as part of 360° view of the entire Slip 4 EAA (1 of 6); Azimuth 0—360° M; 10:18 PDT, water level approximately -1.24 ft MLLW

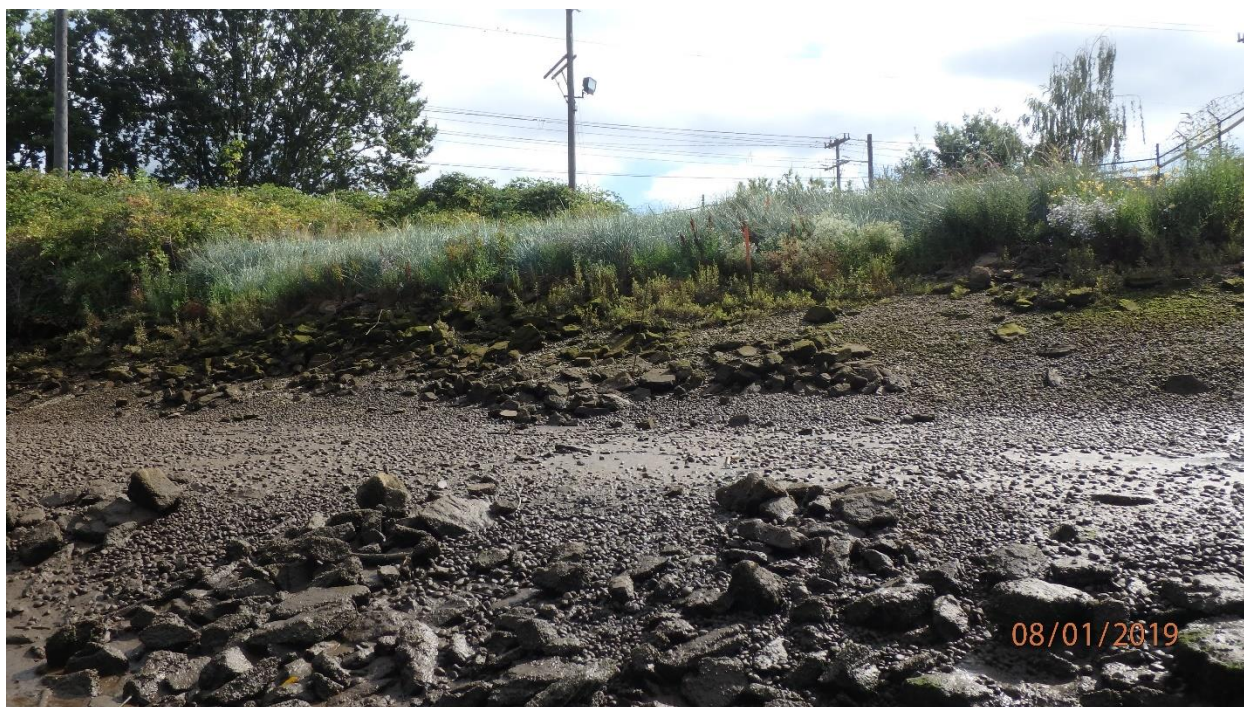
Photo G3.2. Vantage from photo station G looking east as part of 360° view of the entire Slip 4 EAA (2 of 6); Azimuth 0—360° M; 10:18 PDT, water level approximately -1.24 ft MLLW

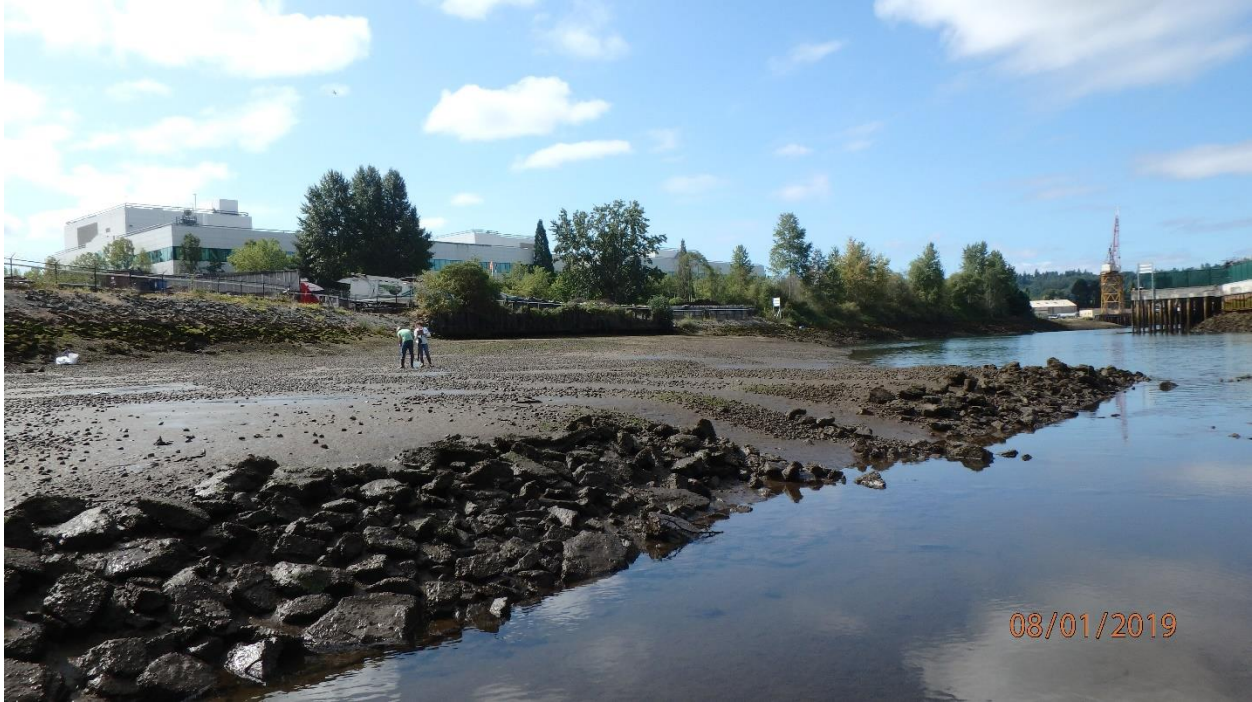
Photo G3.4. Vantage from photo station G looking south as part of 360° view of the entire Slip 4 EAA (4 of 6); Azimuth 0—360° M; 10:18 PDT, water level approximately -1.24 ft MLLW

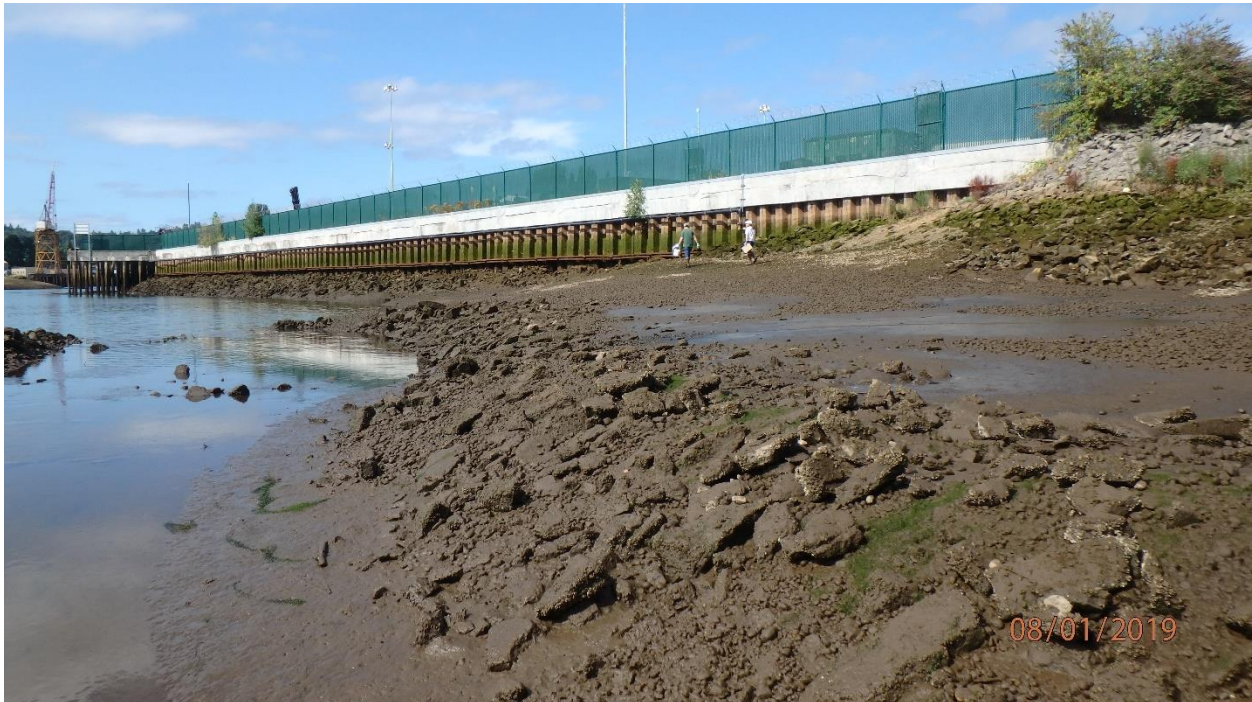
Photo G3.5. Vantage from photo station G looking southwest as part of 360° view of the entire Slip 4 EAA (5 of 6); Azimuth 0—360° M; 10:18 PDT, water level approximately -1.24 ft MLLW

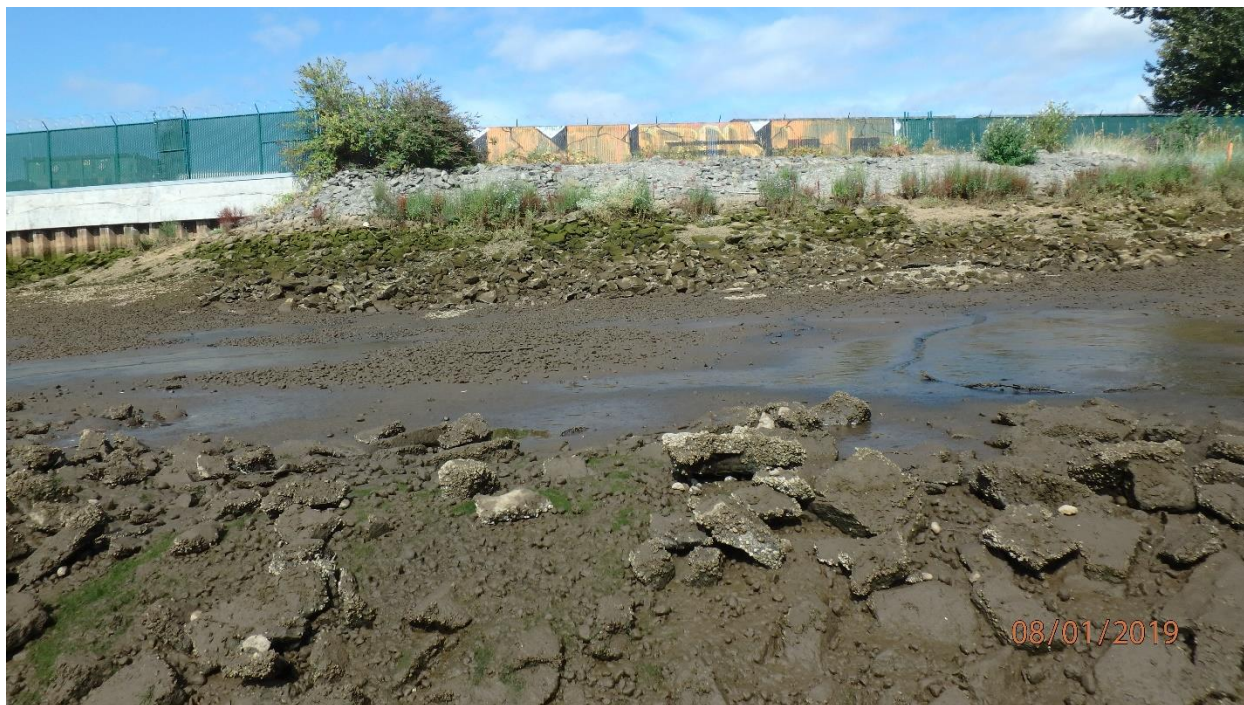
Photo G3.6. Vantage from photo station G looking west as part of 360° view of the entire Slip 4 EAA (6 of 6); Azimuth 0—360° M; 10:18 PDT, water level approximately -1.24 ft MLLW

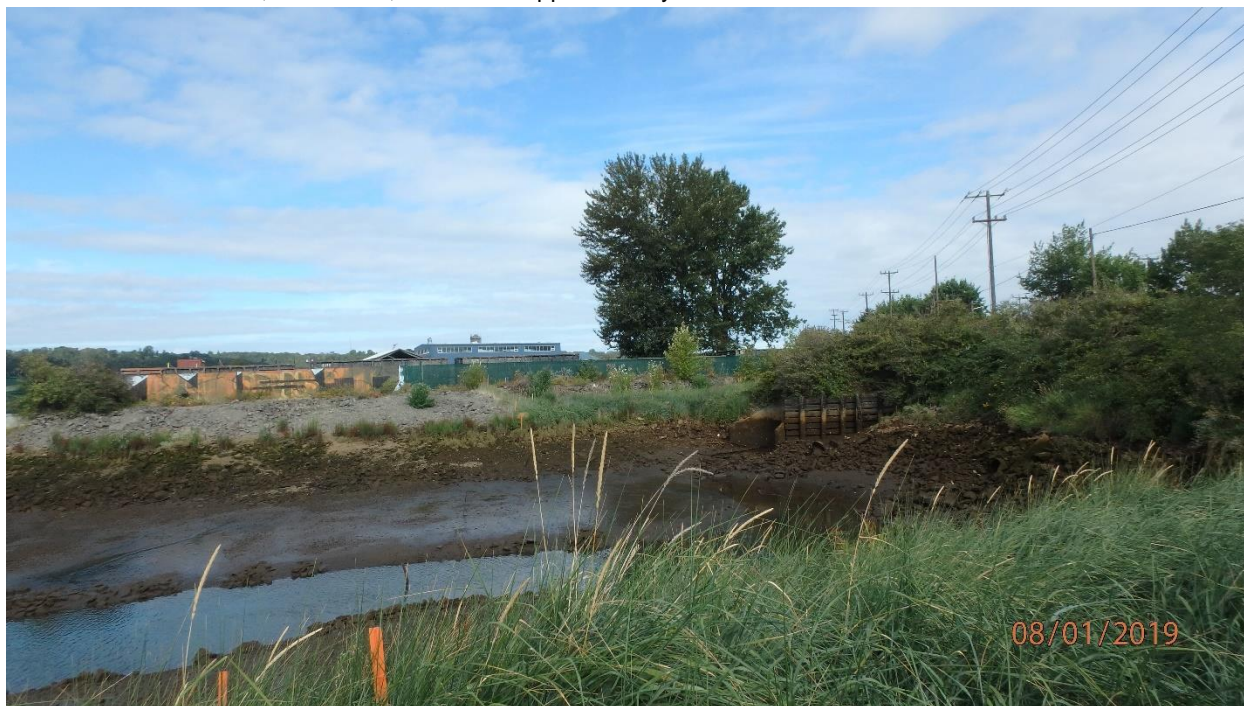
Photo H1. Vantage from photo station H looking northwest toward the northwest slope cap, northwest beach cap, and northwest sediment cap; Azimuth 306° M; 09:38 PDT, water level approximately 0.59 ft MLLW

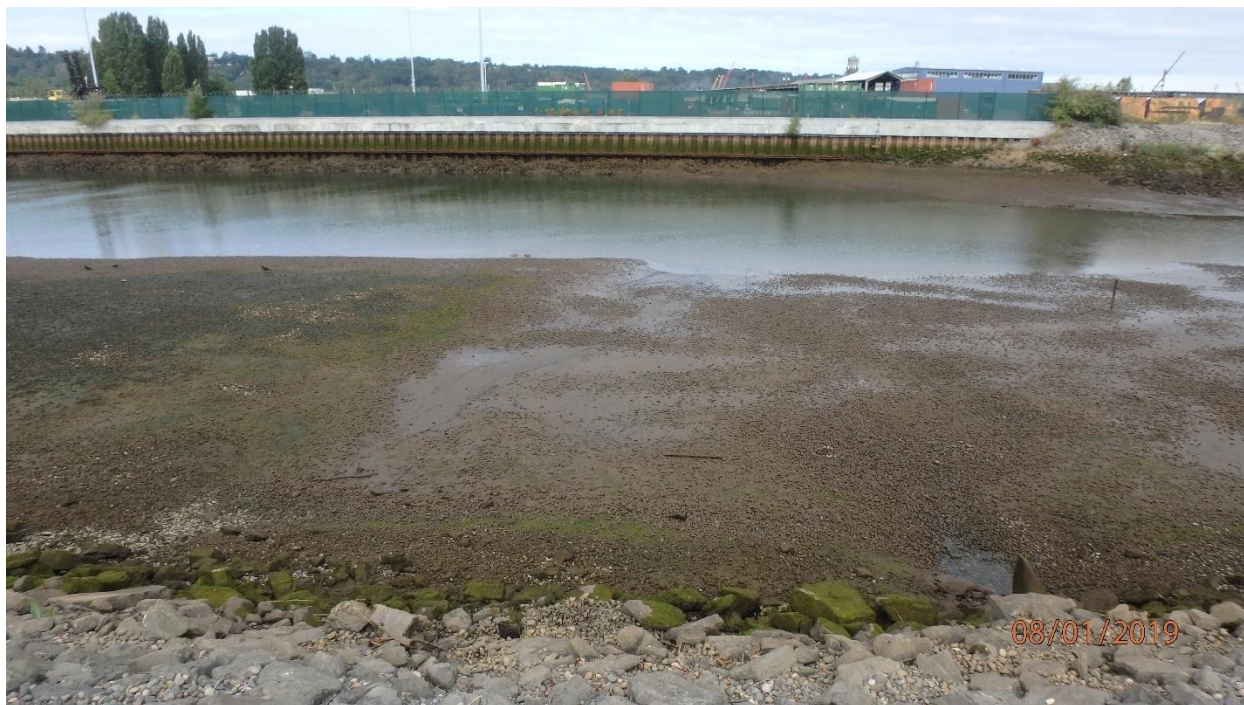
Photo I1. Vantage from photo station I looking west toward the west sediment cap; Azimuth 278° M; 09:22 PDT, water level approximately 1.20 ft MLLW

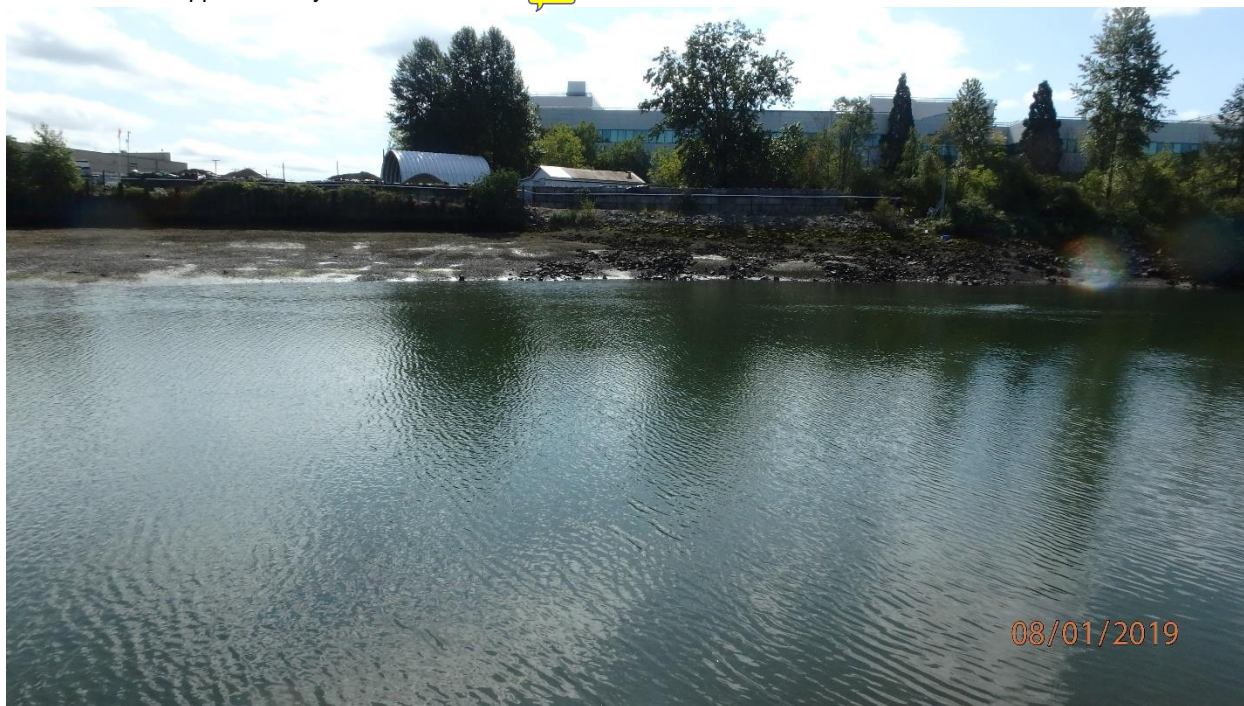
Photo J1. Vantage from photo station J looking southeast toward the southeast slope cap; Azimuth 130° M; 10:36 PDT, water level approximately -1.85 ft MLLW

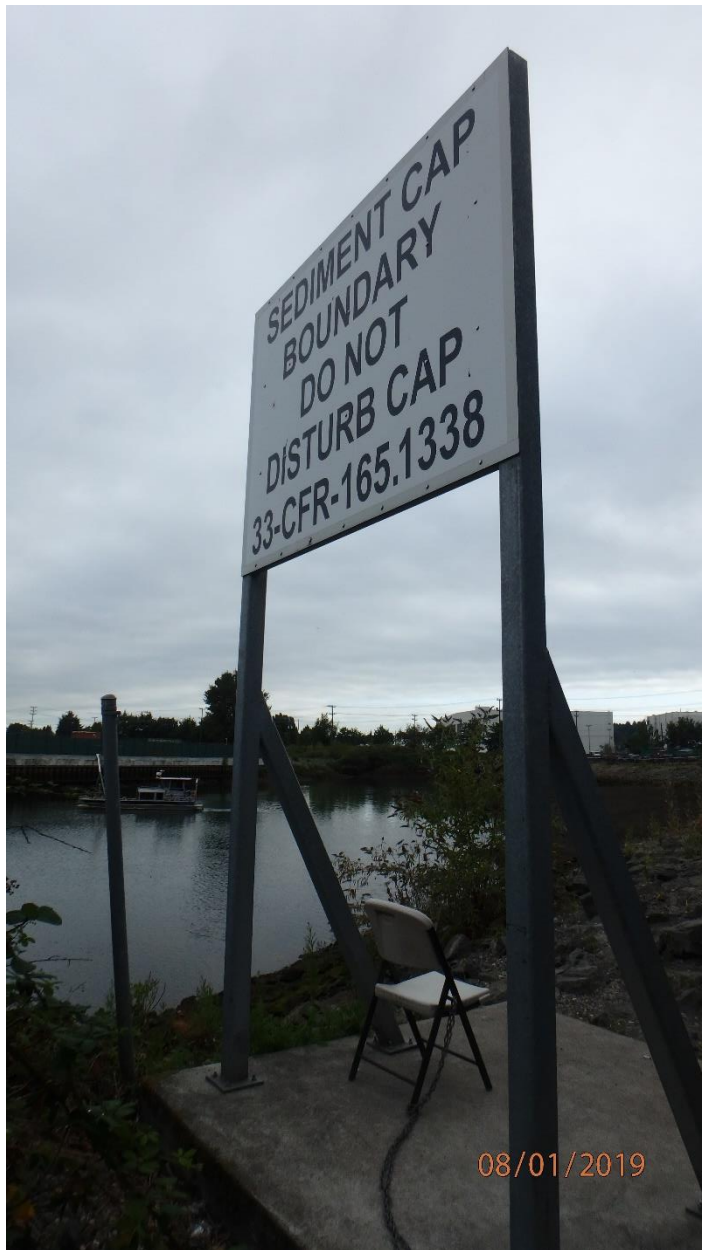
Additional photograph: warning sign at the sediment cap boundary

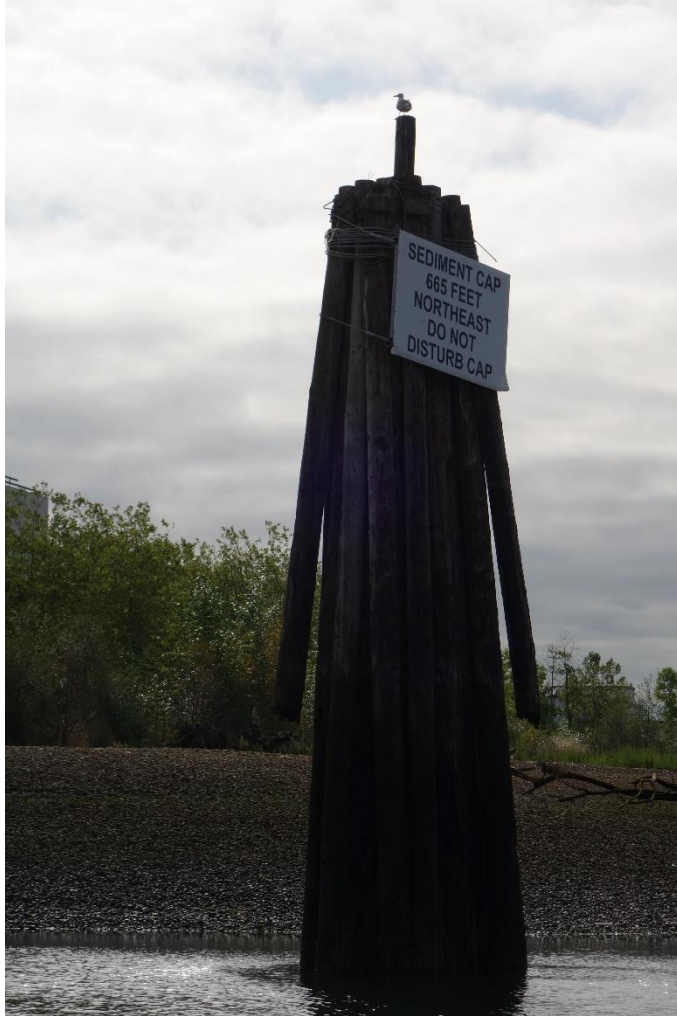
Additional photograph: warning sign at the sediment cap boundary
